Home Appeal Inspections, LLC

Confidential - Property Inspection Report - Confidential

123 New house, Al
Inspection prepared for: New Contruction Example
Real Estate Agent: -

Date of Inspection: 12/1/2020 Time: 700
Age of Home: 2020 Size: 3190
Weather: 65 *

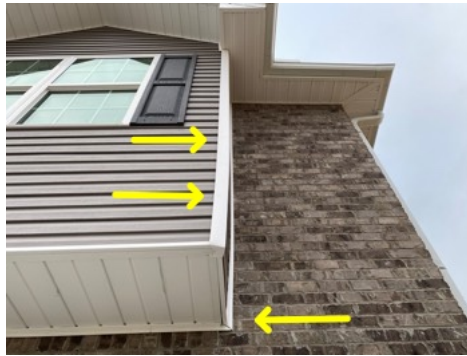
- Inspected
- The right hand side of the bump out above the garage door is bowed and a section of trim at the bottom right corner is not properly fitted.

Bowed trim/unsecured-above garage

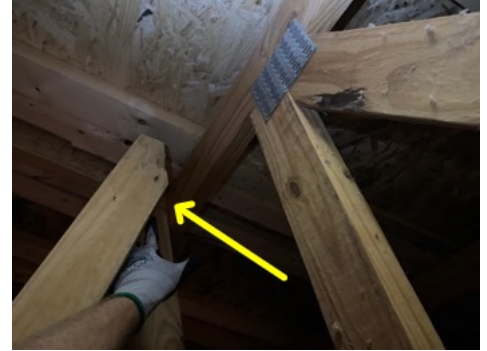
- Inspected- At visible portions.
- A support frame member is unsecured at the top portion above the attic access area. Recommend securing this frame member at the affected area.

Detached frame member-Left of attic access

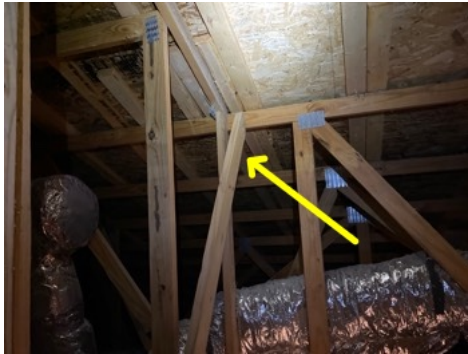
Wide view-Detached frame member

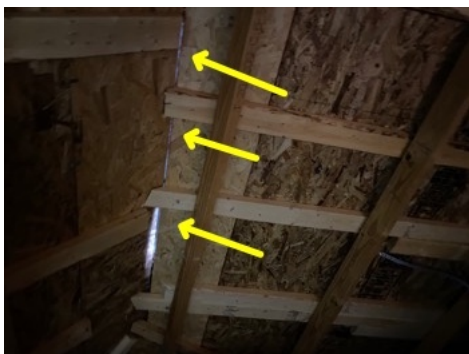
- As viewed from inside the attic above the attic access, it appears that an adequate cutout for ridge venting is not present. Typically, at least one inch of space on each side is recommended for ridge venting. Recommend consulting with the builder for correction.

Minimal ridge vent cut out

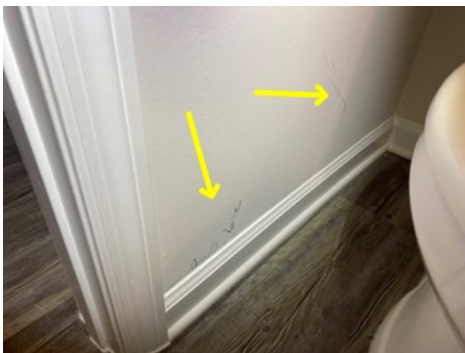
- Note: The paint appears to have been applied in a thin layer, drywall was observed appearing through the paint in multiple locations.
- Multiple scrapes and scratches were noted on walls throughout the home.

Marks on wall beside toilet- hall
bathrooms

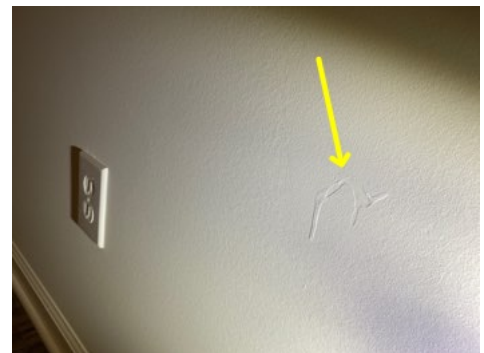
Defect in paint- front bedroom
south wall

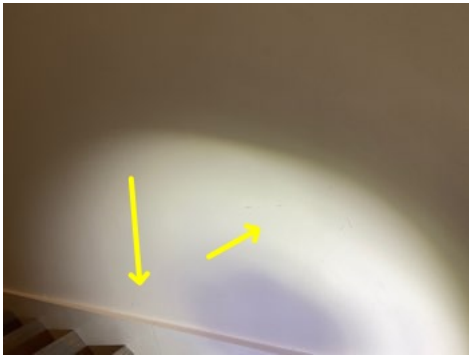
Marks on wall- stairwell

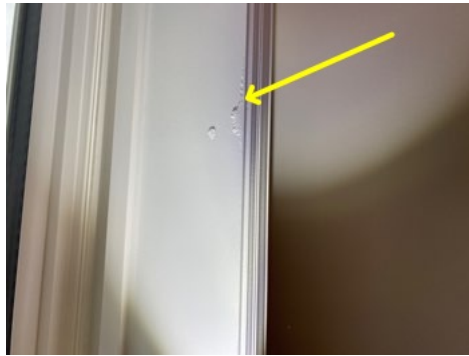
Putty on window trim- head of the stairs

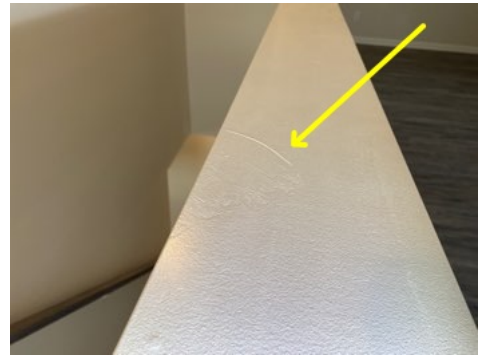
Scrapes in paint- upstairs stairway half wall

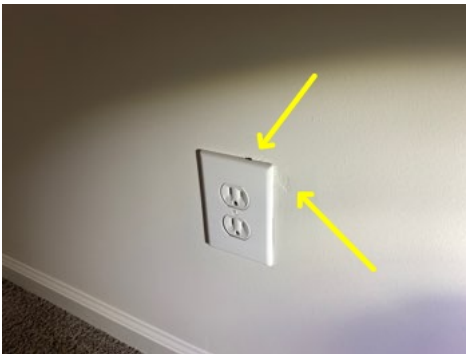
Gap and cosmetic repairs at receptacle plate, East wall upstairs bedroom1

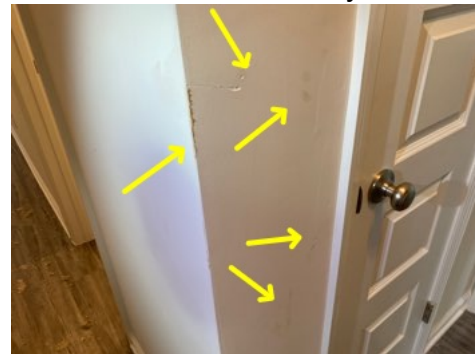
Gouges, scuffs, and dirt at door to upstairs hall closet

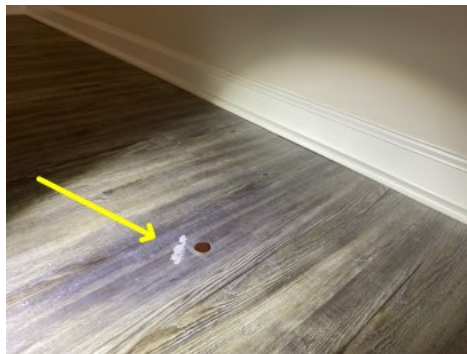
- Note: paint or putty was observed on the floor of the upstairs bonus room in multiple locations along the north wall.

Paint on floor- bonus room

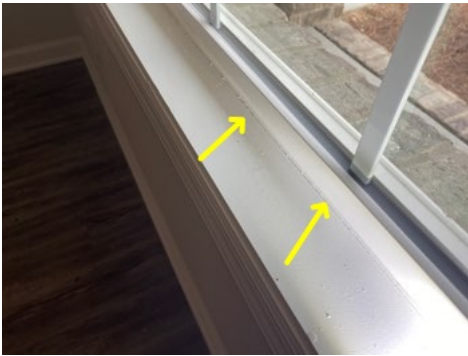
- Note: the caulking around the windows in the front bedroom appears to be incomplete. A gap was observed at the upper left side, along the top, and at the upper right side.

Crack in caulking- front bedroom, left side

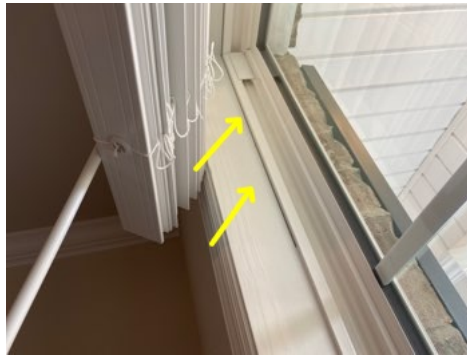
Incomplete caulking- front bedroom

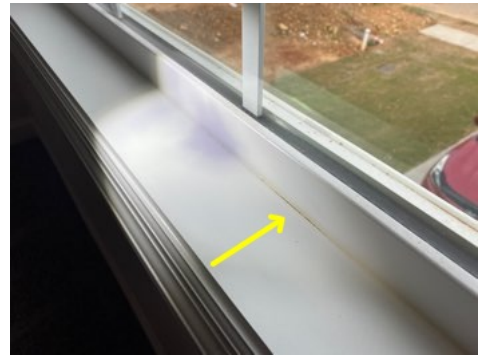
Crack in caulking- upstairs bedroom1

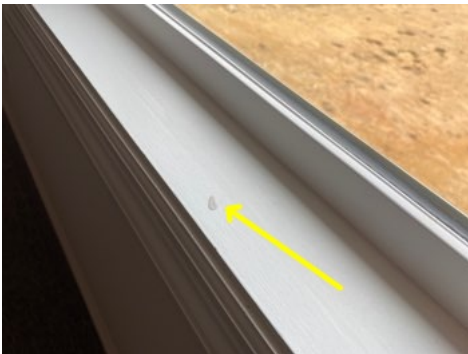
Paint on windowsill- upstairs bedroom2

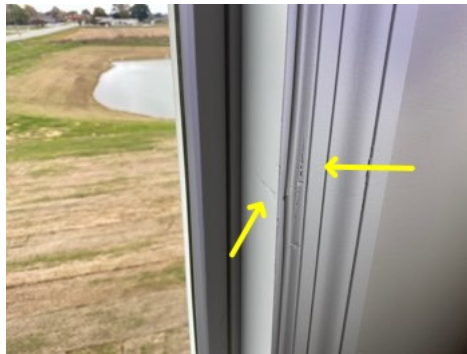
Crack and gouges in window trim- bedroom2

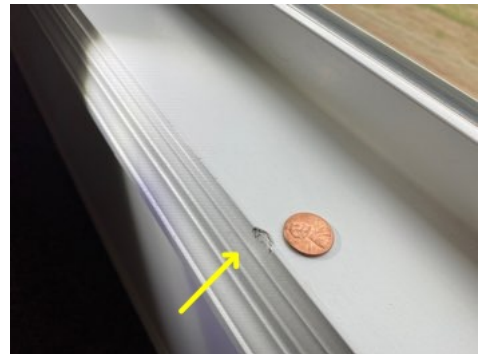
Dent in windowsill- upstairs bedroom2

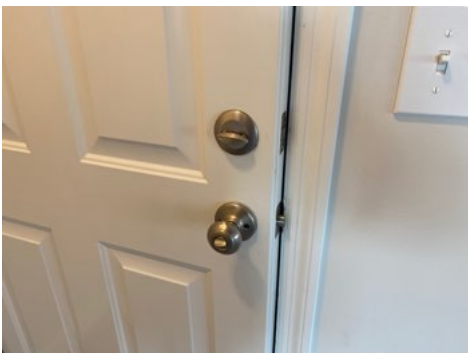
- Repair or replace: the garage service doorknob does not readily latch or turn. Recommend review by the contractor prior to walk through.
- Note: paint was observed on multiple door hinges throughout the home.
- Door stops are not installed at all door locations. Install at all affected areas.

Door knob does not operate smoothly- garage interior door

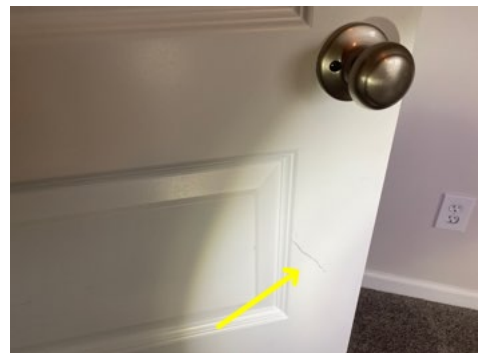
Scratch on the inside of the closet door- upstairs bedroom1

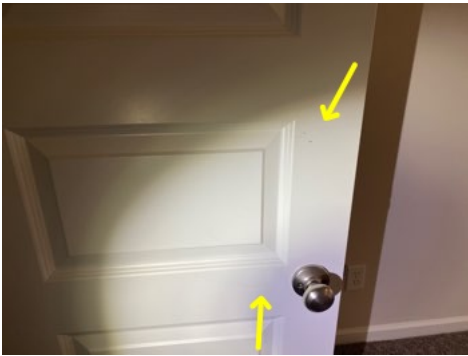
Scratches in finish- inside closet door bedroom2

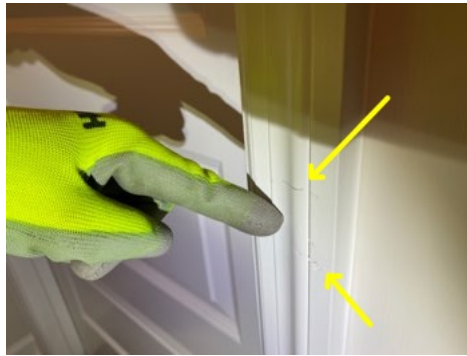
Scratches and gouges in laundry room door trim

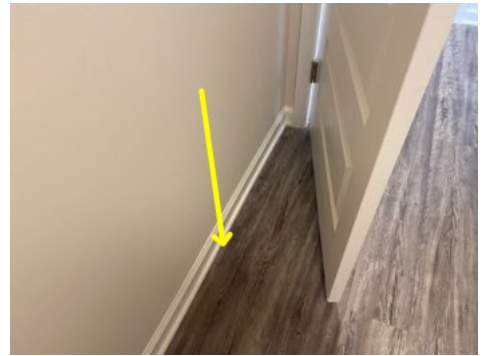
No doorstop- laundry room door

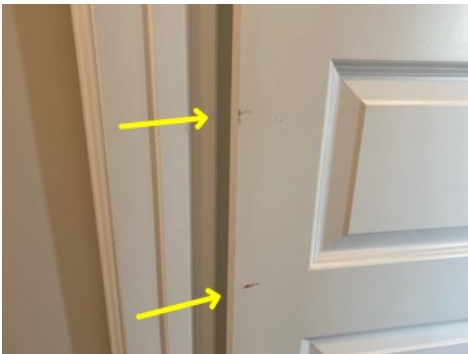
Scrape and dirt on master bedroom door

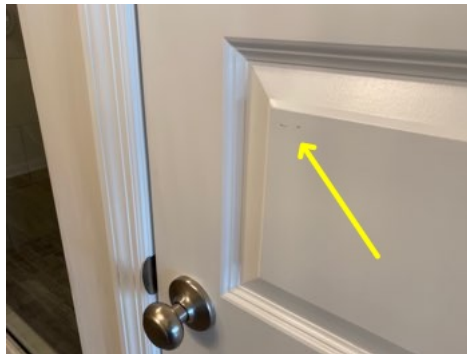
Scratch- master bath closet

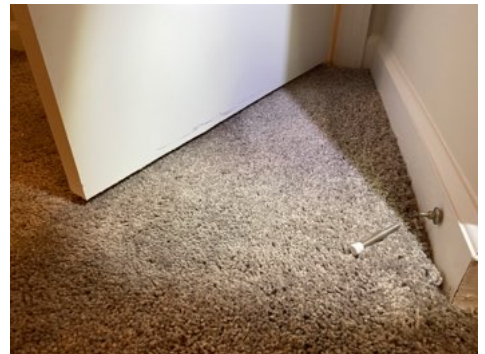
Scratches on the inside of the master closet door, poorly installed/broken door stop

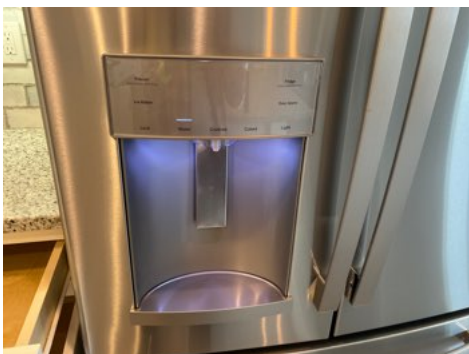
- Ice and water dispenser tested. No water or ice would flow when dispenser was pressed. Plumbing for the dispenser appears to be present. Recommend review by the contractor prior to walk through to review and repair as needed.

No water or ice at dispenser

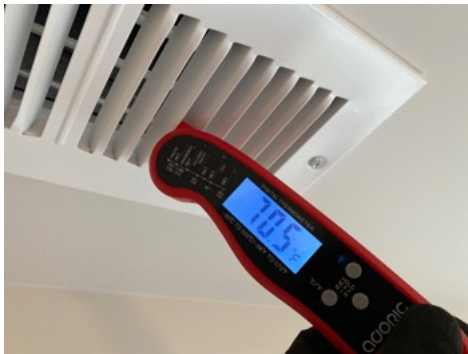
- When the upstairs thermostat was called for cold air demand, the system did not turn on as expected. After 30 minutes of wait time the unit was turned off. Recommend review by a licensed HVAC technician.
- A return air register is not installed for the upstairs. Recommend consulting with a licensed HVAC technician to ensure adequate return air is possible for the upstairs area.

Upstairs register did not produce cold air

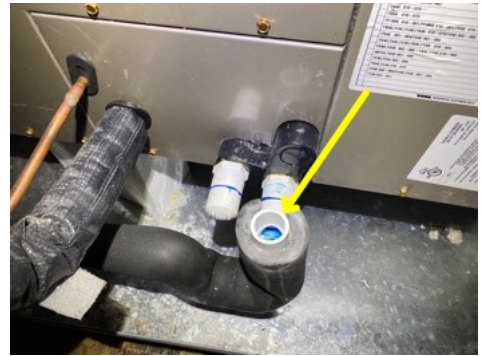
- A cap has not been installed on top of the primary condensate drain. Install at the affected area.

No cap

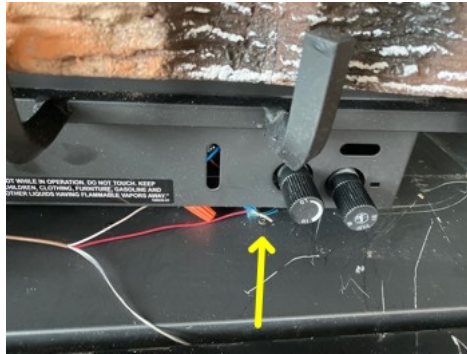
- The gas valve is off for the gas logs. The system was not tested. It is noted that a wire nut is missing on the low voltage wiring near the controls of the fireplace logs.

No wire nut-Fireplace

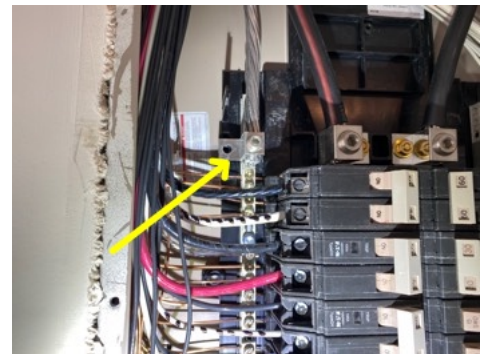
- Inspected
- The bond screw has been loosened on the neutral bus as expected and the bonding strap has been removed. However, a bonding screw was not observed to be bonding the ground buss to the panel. Recommend review by a licensed electrician to ensure the ground buss bar is bonded to the panel.

Bond screw not identified on ground buss.

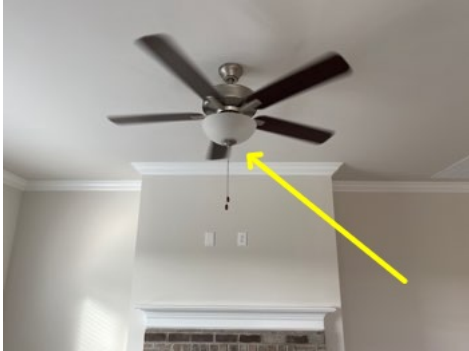
Ceiling fan light in living room did not operate with expected switches

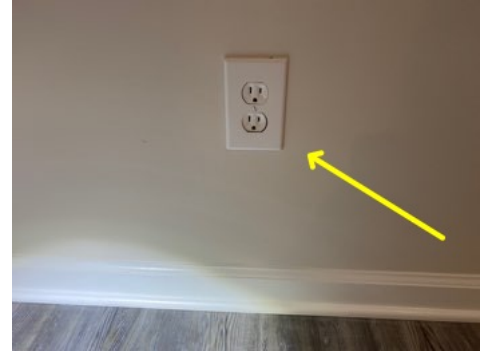
- Inspected
- Note: receptacles that are not flush with the face plate were observed throughout the home.
- Note: it was observed that there is no lighting in the majority of the closets.

Receptacles are not flush with the faceplate

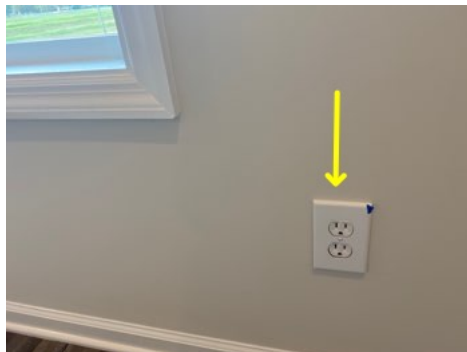
Loose outlet- upstairs bedroom3

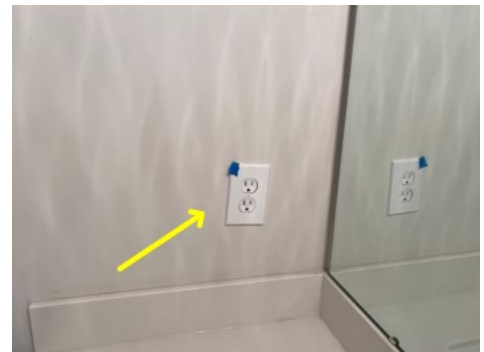
Crooked receptacle- master bath

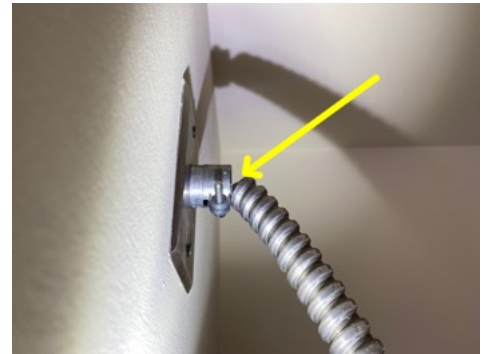
- Inspected
- The conduit is strained for the water heater electrical feed. This condition has pulled the conduit out of the bushing at the wall. Recommend repair by a licensed electrician. Suggest adding more slack for this circuit.

Conduit strained/pulled from clamp-Water heater
