Home Appeal Inspections, LLC

Confidential - Property Inspection Report - Confidential

123 New house, Al
Inspection prepared for: New Contruction Example
Real Estate Agent: -

Date of Inspection: 12/1/2020 Time: 700
Age of Home: 2020 Size: 3190
Weather: 65 *

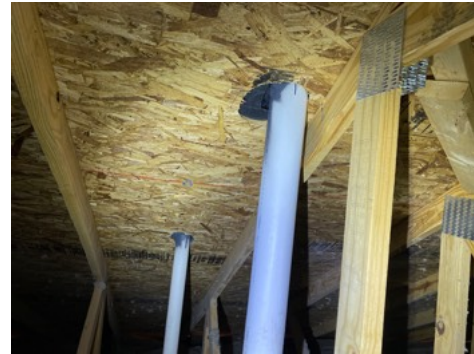
Vent stack penetration view- No staining

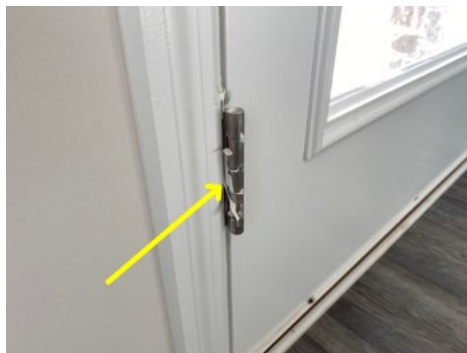
Paint on door hinges

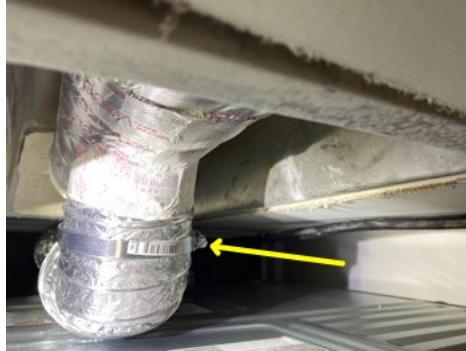
- Note: the hose clamp securing the dryer vent hose is not tight.

The hose clamp securing the dryer hose is not tight

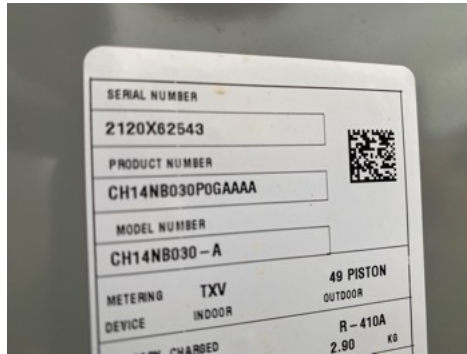
Data tag for condenser-2020-11/2 ton

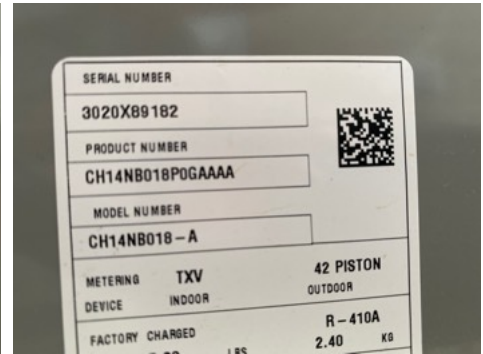
Data tag for condenser-2020-21/2ton

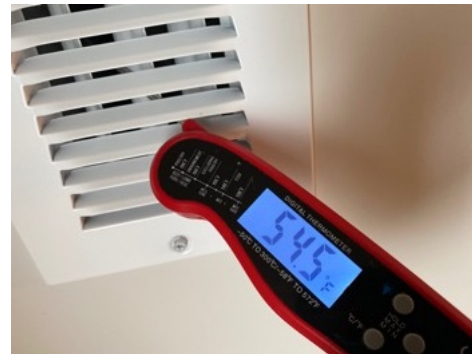
Cooling at register down stairs

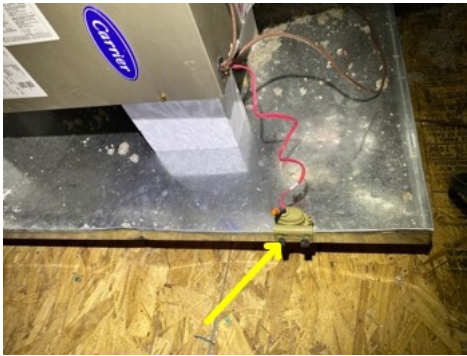
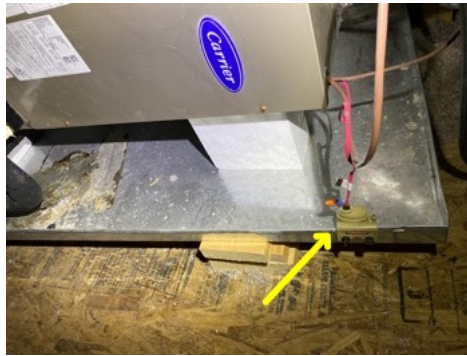
Overflow sensor present

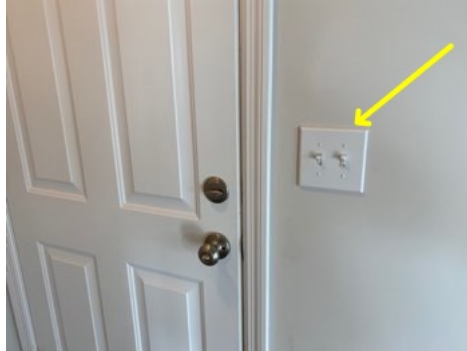
Switches by garage service door do not appear to operate any fixtures

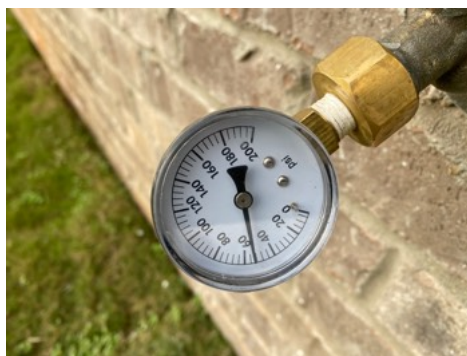
55psi

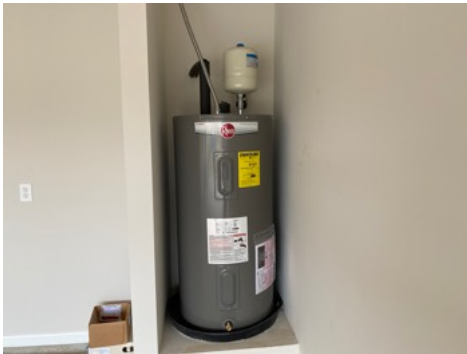
Water heater view

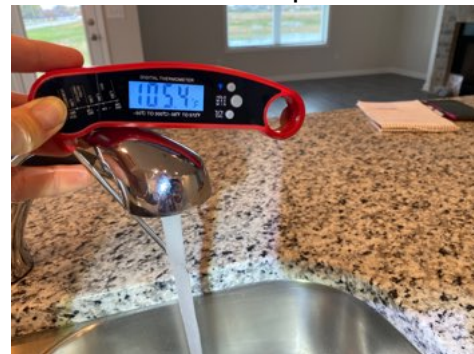
Water heater Temp

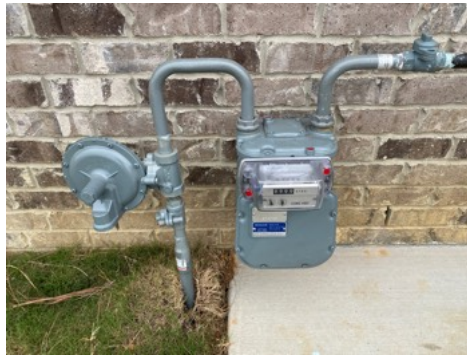
- Inspected
- The meter was locked at time of inspection.

Gas meter view
